Inspection Report
Minerals Regulatory Program
Report Date: April 7, 2005

Mine Name: Happy Jack

Permit number: M/037/024

Inspection Date: March 10, 2005

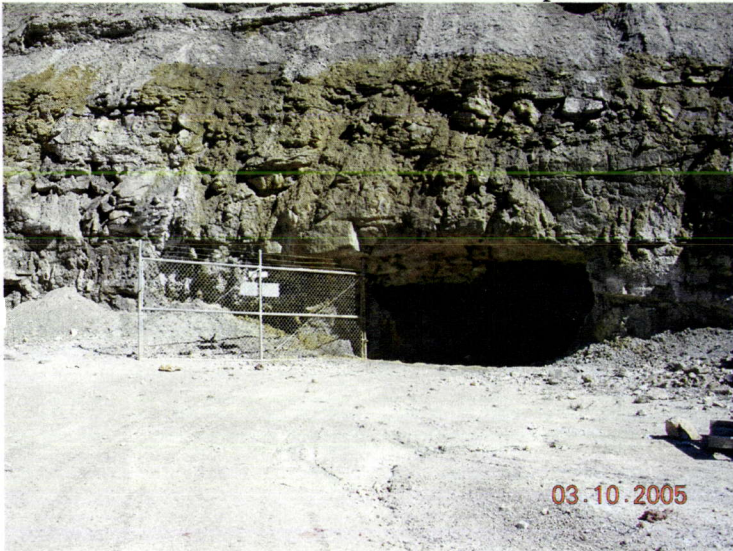
There are four open portals, three of which are gated (Photos 1 and 2 show one of the gated portals). There is also one shallow dog hole (Photo 2). One of the gated portals is not being used because of unstable roof conditions. The ungated portal is partially caved and silted in, and a large rock has now fallen in front of the portal making it inaccessible. Two gated portals are connected through underground workings which have natural ventilation. This underground area is used to store inventory (Photos 3 and 4). Most of the storage areas are within about 100 feet of the portal openings, and Mr. Isenhardt said none of the open workings goes back more than about 100 yards.

I do not consider the open underground workings to be a particular danger to the public because they are not extensive, they are part of an active business, and because they have gates that can be closed when the areas are not in use.

Photo 1. One of the gated portals that leads into the storage area.

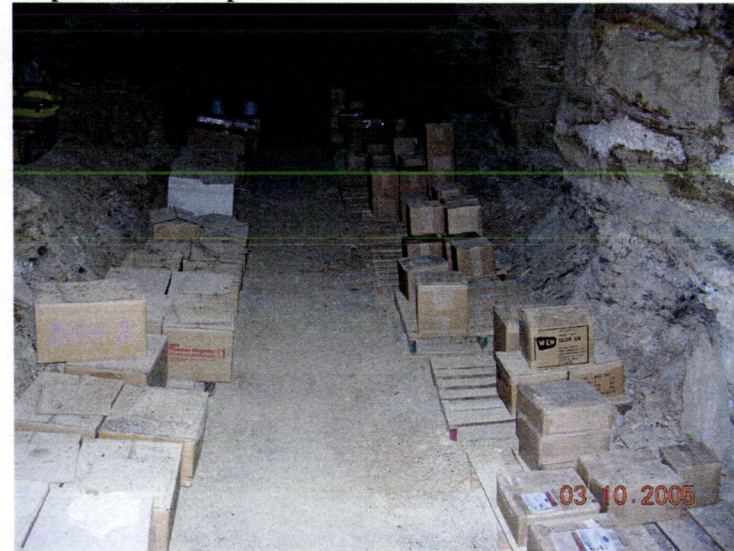
Photo 3. Some of the underground storage area.

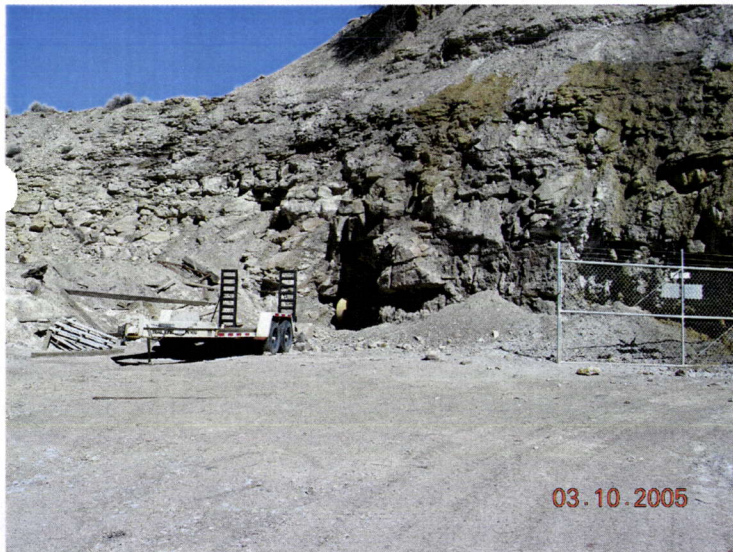
Photo 2. Near the center of this picture is a dog hole (not a portal).

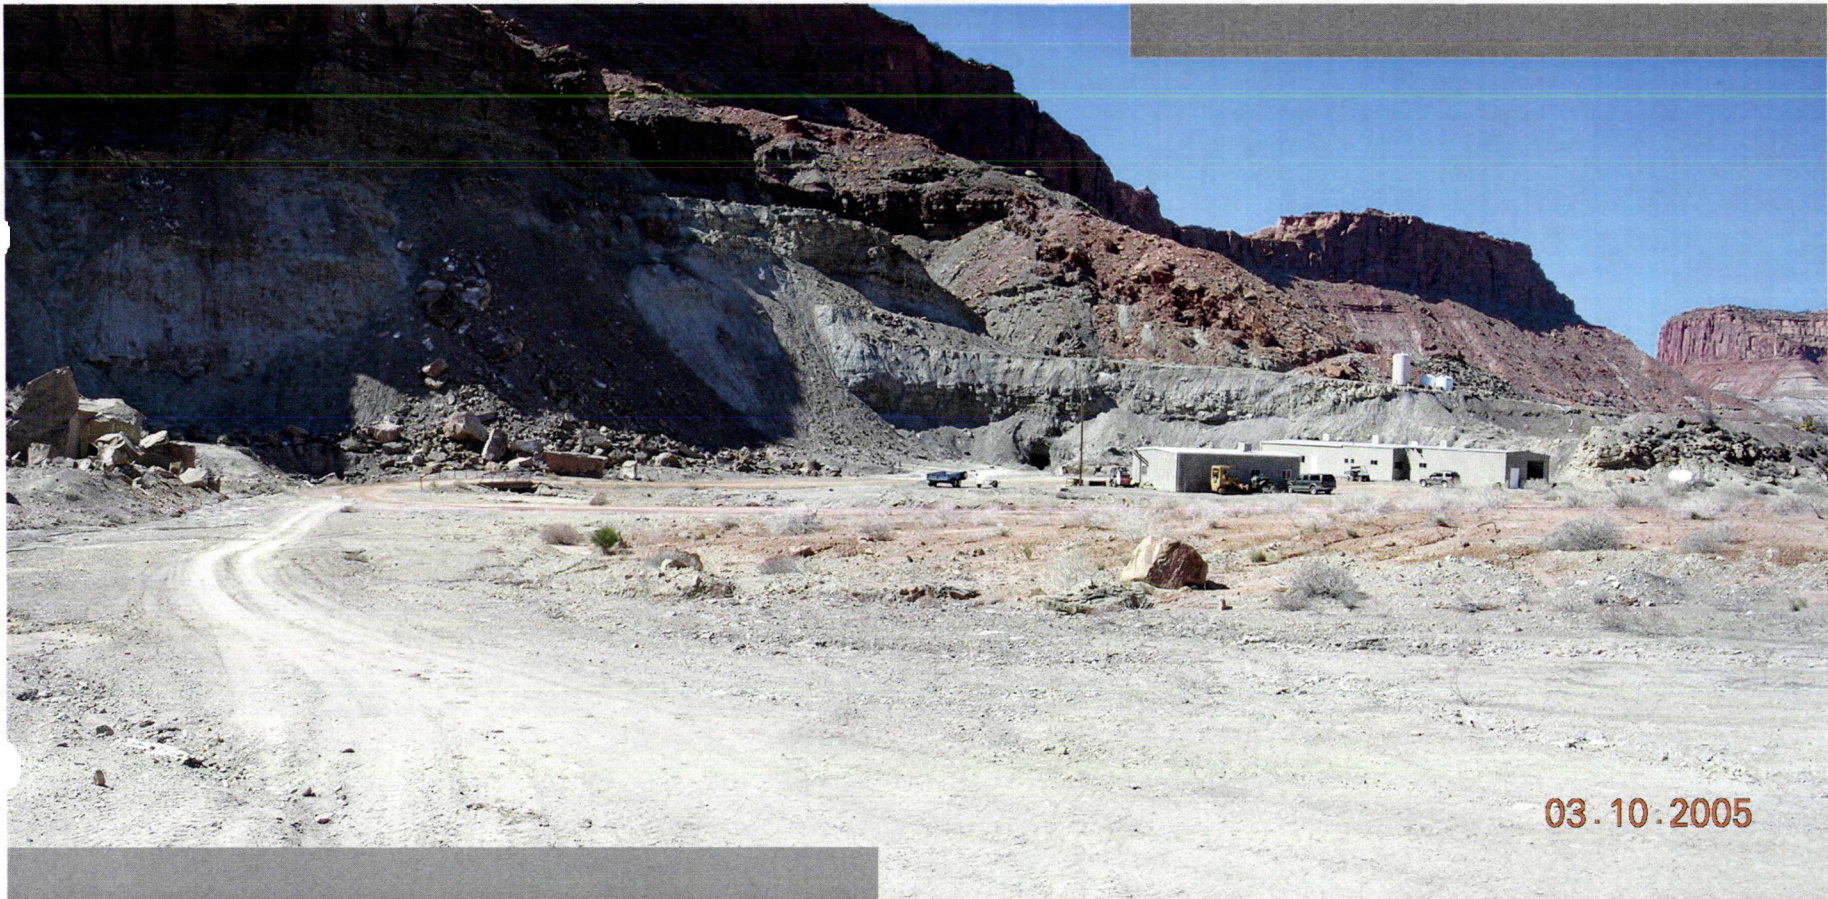
Before the permit was transferred to Mr. Isenhardt, the Division had agreed that reclamation was complete except for revegetation. At the time, the portals had been sealed and backfilled, and there was no plan to use the site for a commercial operation. A red sandy topsoil was spread over part of the pad (center of Photo 5), and this was seeded. This area contains a moderate amount of vegetation, but I did not measure cover.

Photo 5. An overview of part of the pad. The office/warehouse building is on the right, and the other building is a shop. The caved, gated portal is in the bank just to the left of the center. The red soil is the topsoil that was spread and seeded.
